Navajo Abandoned Uranium Mine

Site Screen Report

Mesa III, West Mine AUM Site

Navajo AUM Northern Region

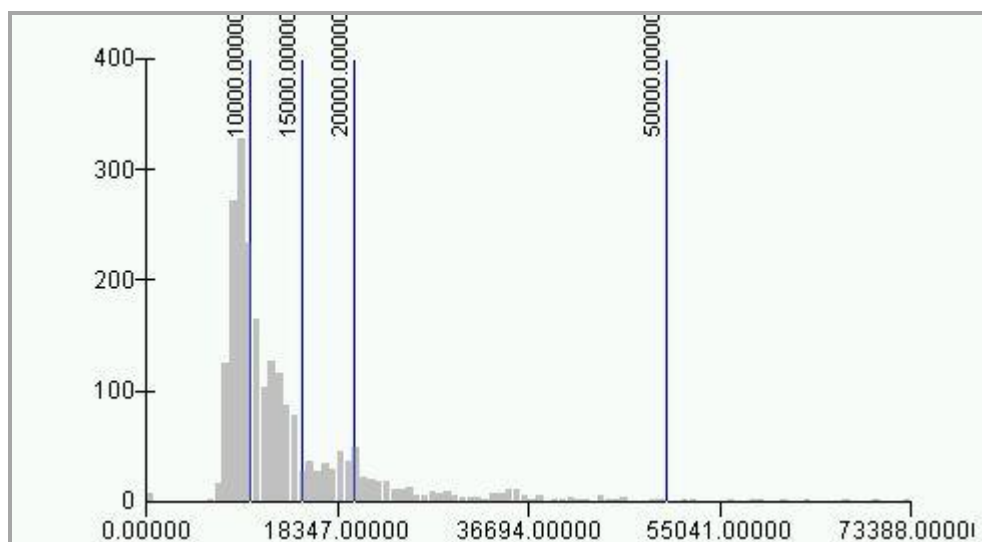
The following chart and statistics were generated by ESRI ArcGIS 9.3.1, and show the general distribution of the site gamma radiation measurements. The horizontal X axis represents the gamma radiation reading levels in cpm (lowest levels to the left). The vertical Y axis represents the frequency of each gamma radiation level.

Count:	2189
Minimum:	0.00000
Maximum:	73388.00000
Sum:	29387020.00000
Mean:	13424.86067
Median:	10719.00000
Standard Deviation:	7474.26552

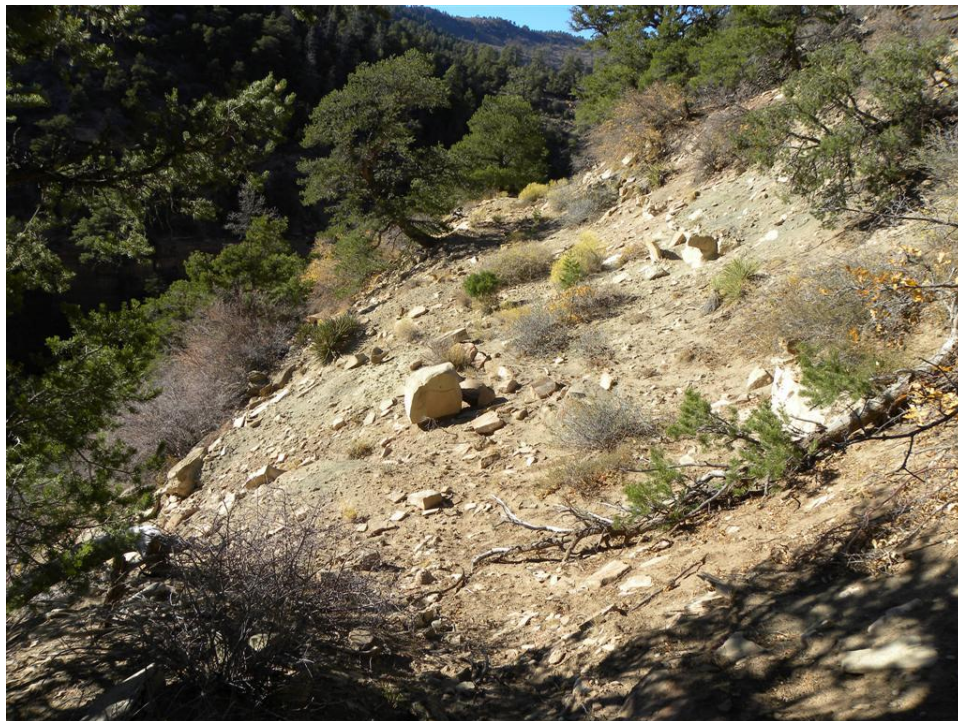
Large waste pile along edge of cliff, with a total estimated volume of 1,852 yd³

Photo 1. Waste debris sloping down to cliff

Unreclaimed waste pile

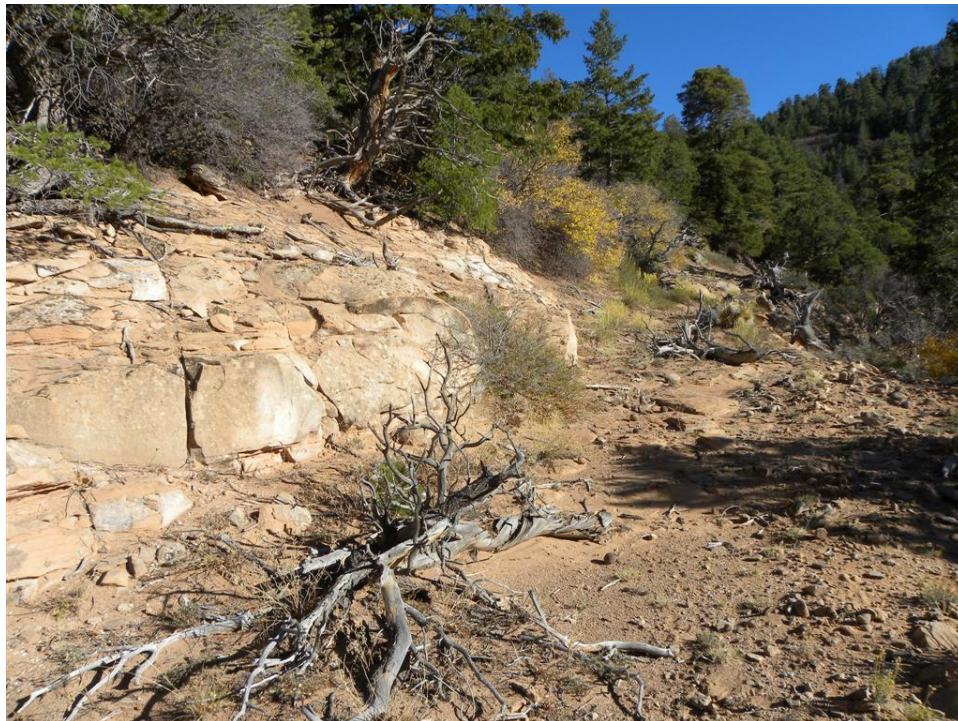
Photo 2. Mine site pathway

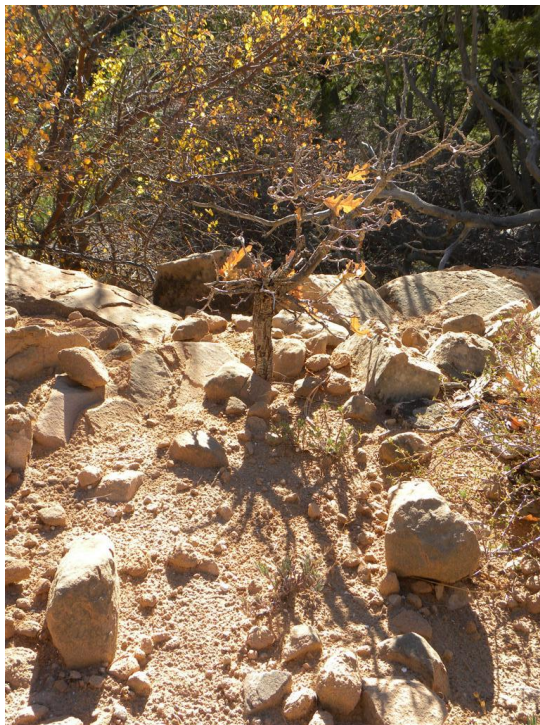
Photo 3. Waste debris heading down cliff

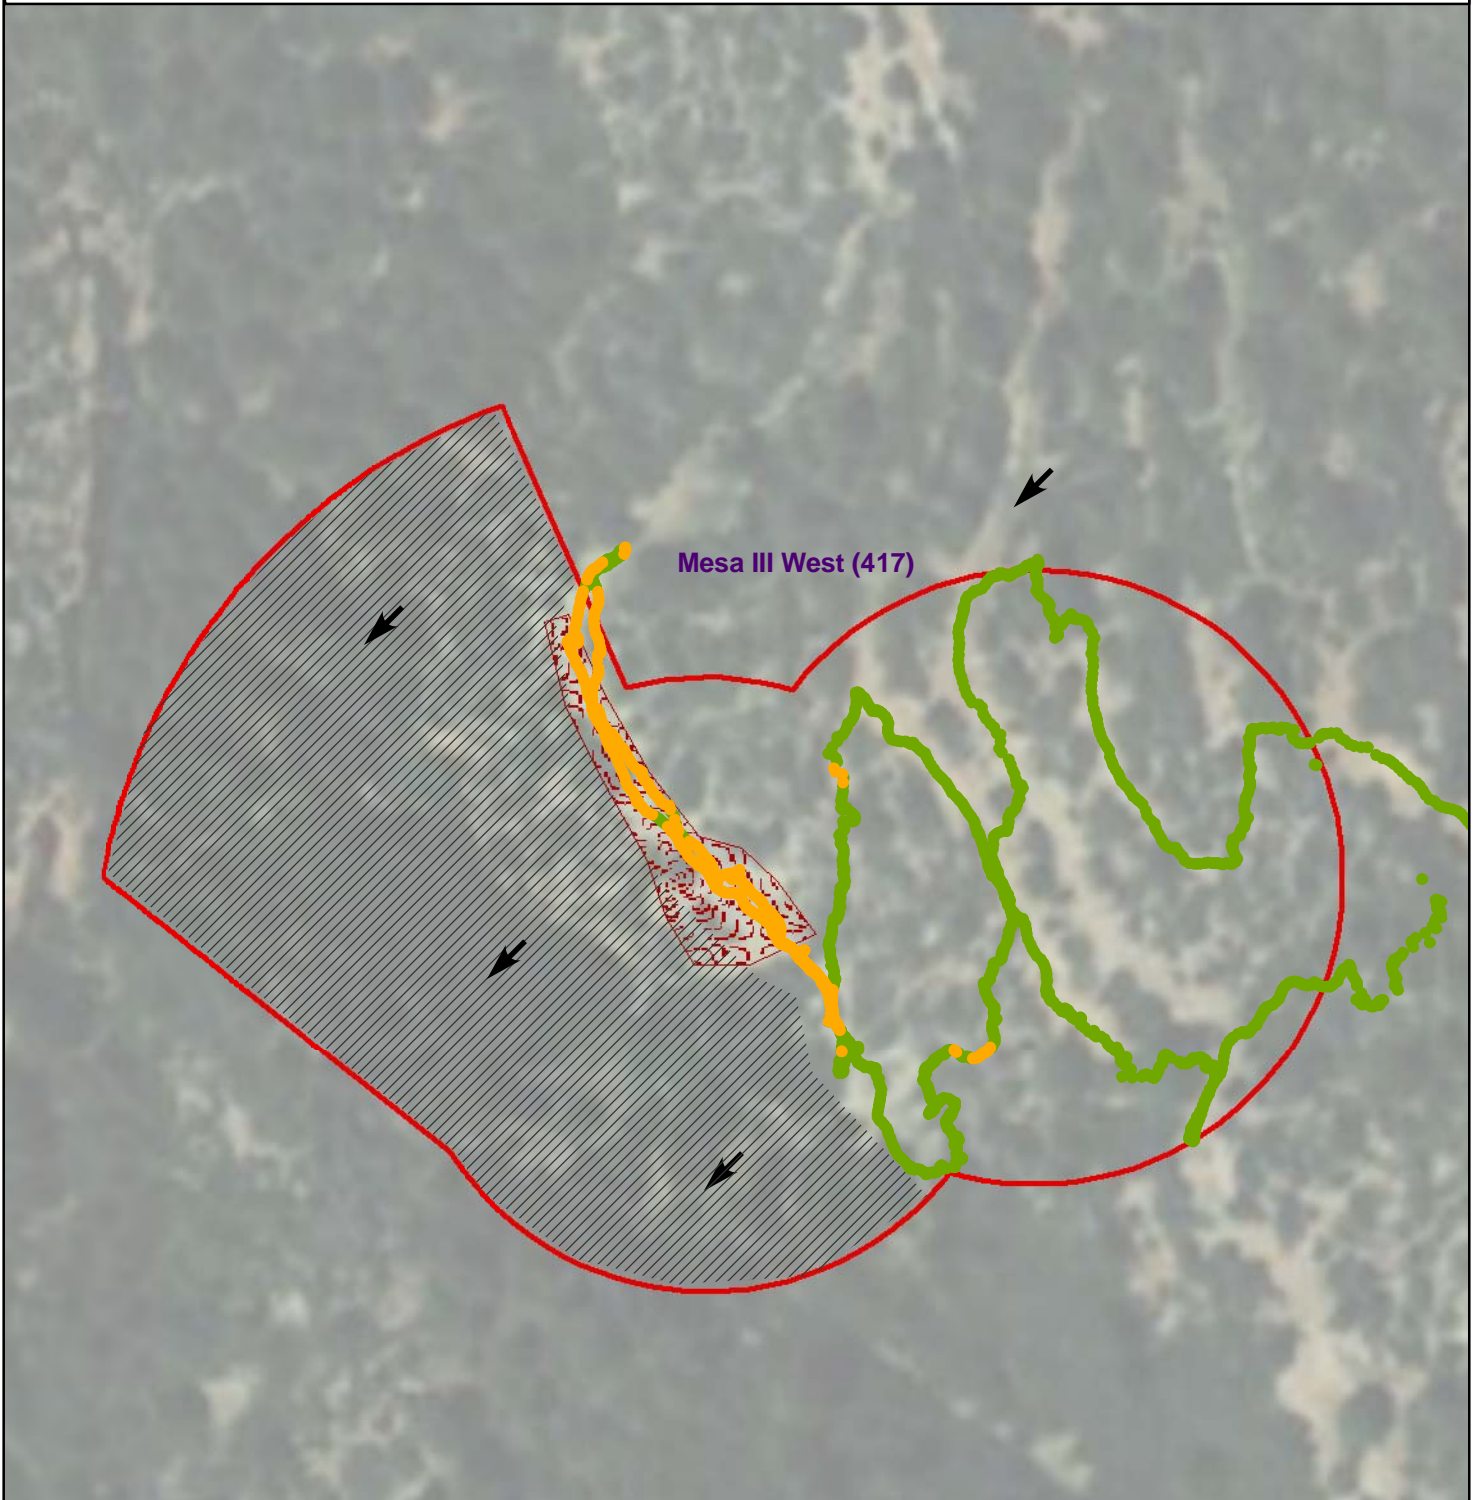
**Figure 1 - Gamma Radiation Measurements, Above Two Times Background
Mesa III West (417)
Cove Chapter, Navajo Nation, Arizona**

A total of 2,181 gamma radiation measurements were collected from the mine site, ranging from 6,586 cpm to 73,388 cpm. Measurements in the vicinity of the waste debris were found at levels of approximately 70,000 cpm. The measurements are represented in Figures 1 and 2.

Gamma survey conducted 10/2009
Measured as counts per minute (cpm)

Average background = 8,037 cpm

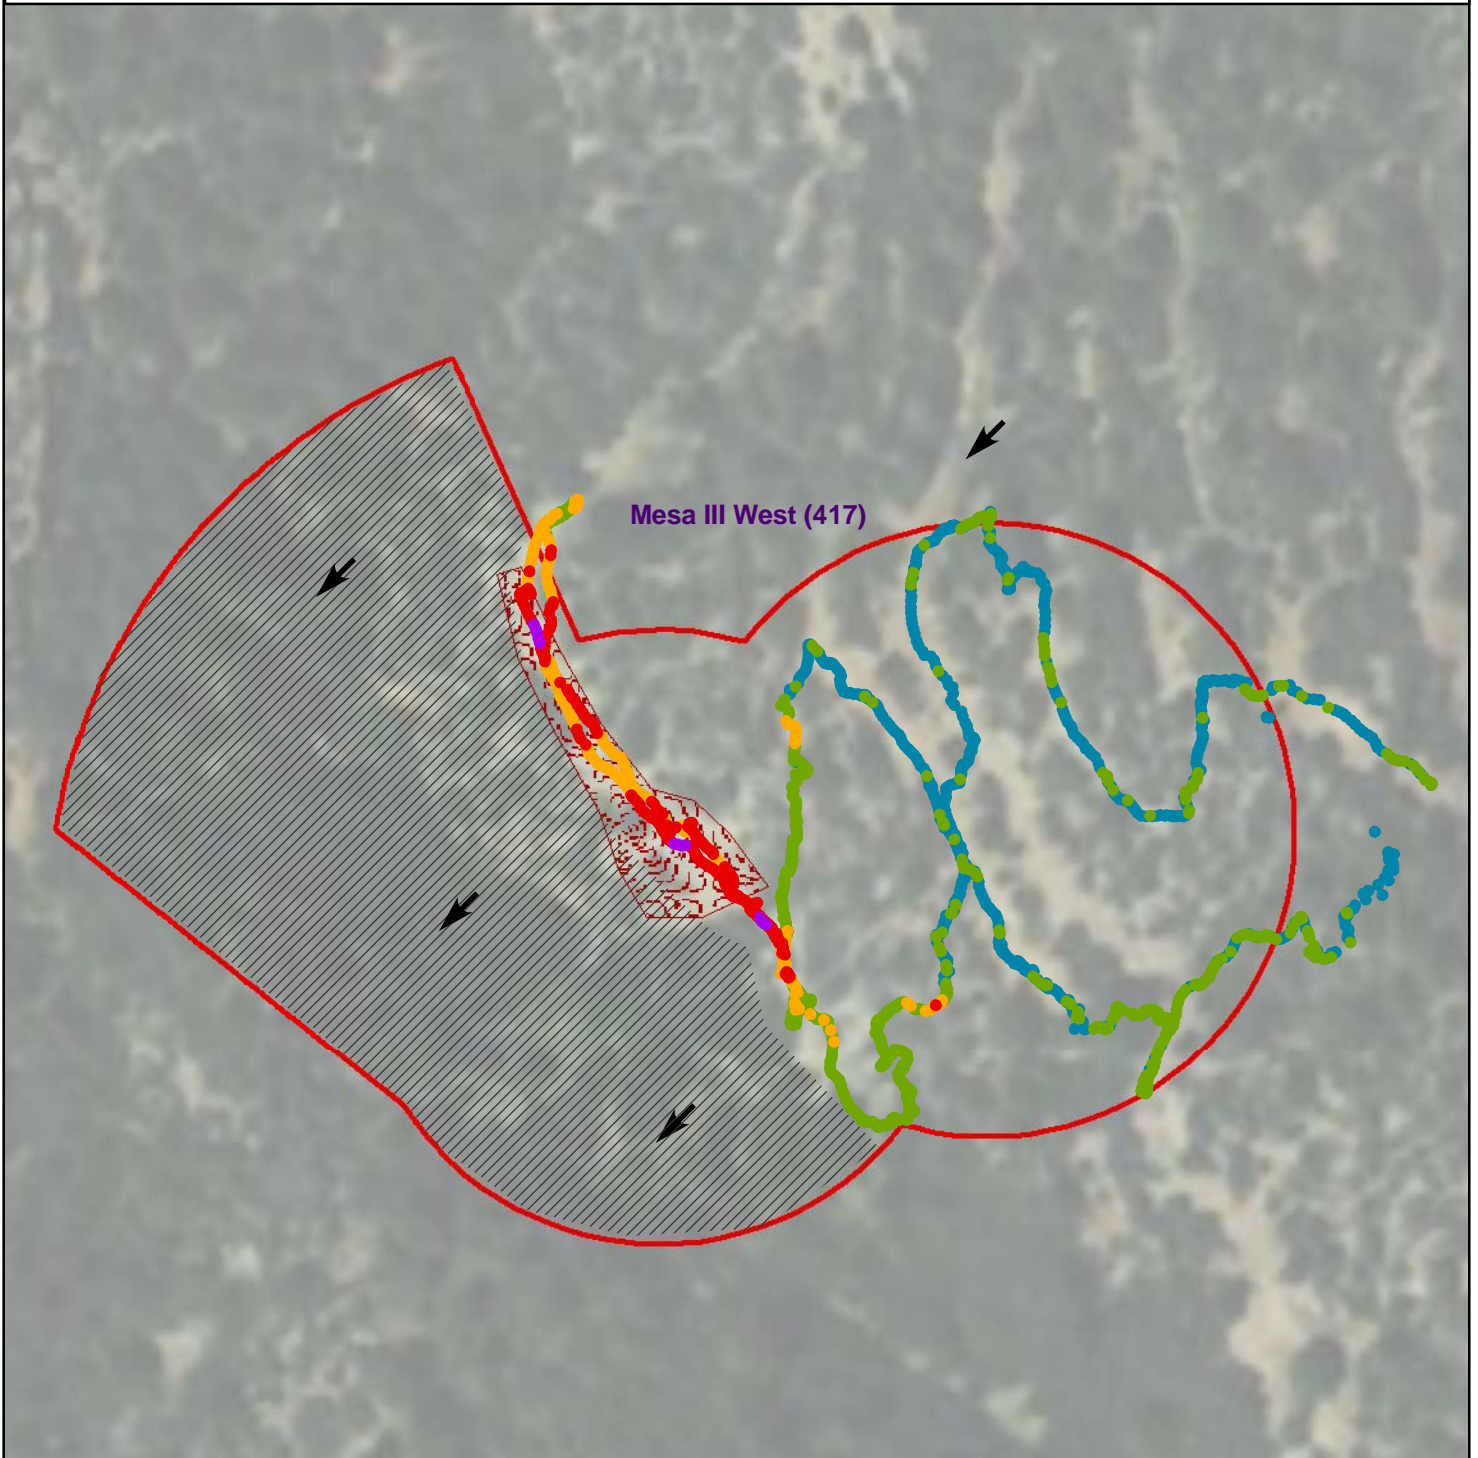
Figure 2 - Gamma Radiation Measurements
Mesa III West (417)
Cove Chapter, Navajo Nation, Arizona

Gamma survey conducted 10/2009
Measured as counts per minute (cpm)

Average background = 8,037 cpm
